RE: Arborist Consulting Services for the project: 2010 Humboldt St, APN #036-054-023-000, City of Yountville jurisdiction, CA

Thank you for contacting Focal Point Arboriculture Consulting to evaluate the trees along the street on both Jefferson St and Humboldt St to provide an opinion as to the condition of the trees with respect to their health and structural adequacy to remain on the site during development of the parcel. The property is 2010 Humboldt Street, on the northeast corner of Humboldt and Jefferson Street in Yountville, CA, and is subject to the jurisdiction of the City of Yountville, CA.

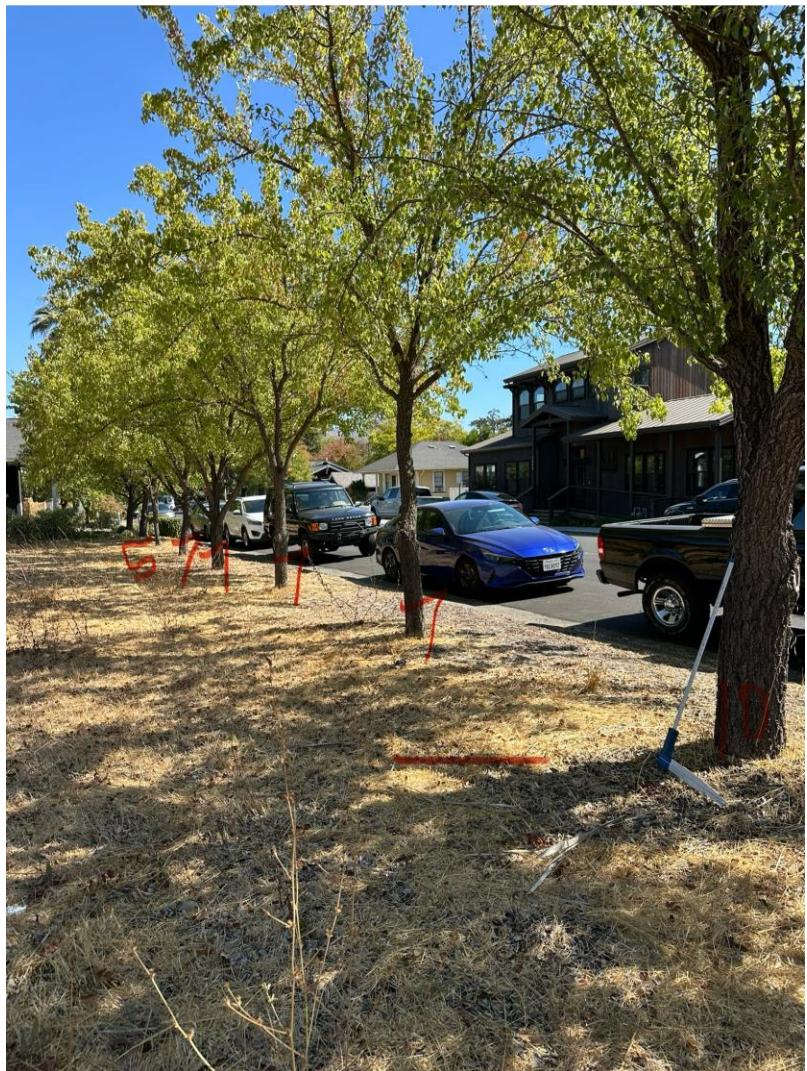
I visited the site on September 24th, 2024, to evaluate the trees and onsite conditions. The majority of the trees are Ornamental Pear, *Pyrus calleryana*, measuring between 5" and 10" diameter<sup>1</sup>. They are declining due to lack of care and irrigation. The canopy opacity<sup>2</sup> on most of the trees is less than 40% but it is noted that many twigs remain and appear to be live. None of these trees have grown to their potential in the current situation despite the length of time they have been there, approximately 18 years (They appear to have been planted in late 2006 or early 2007). This species of tree was widely planted in landscapes and as street trees 40 years ago and can generally be counted on to perform well for 30 to 40 years before structural breaks from the narrow branch structure become predominant and they have to be replaced. The civil plans<sup>3</sup> show grade changes right up to the back of the sidewalk, replacement of the sidewalk and curb and gutter. It is my professional opinion that the current condition of these trees combined with the likely root impacts will likely cause the demise of the trees and their remaining lifespan is short.

Photo #1. Trees along Humboldt Street. Opacity appears better in the photo than it actually is.

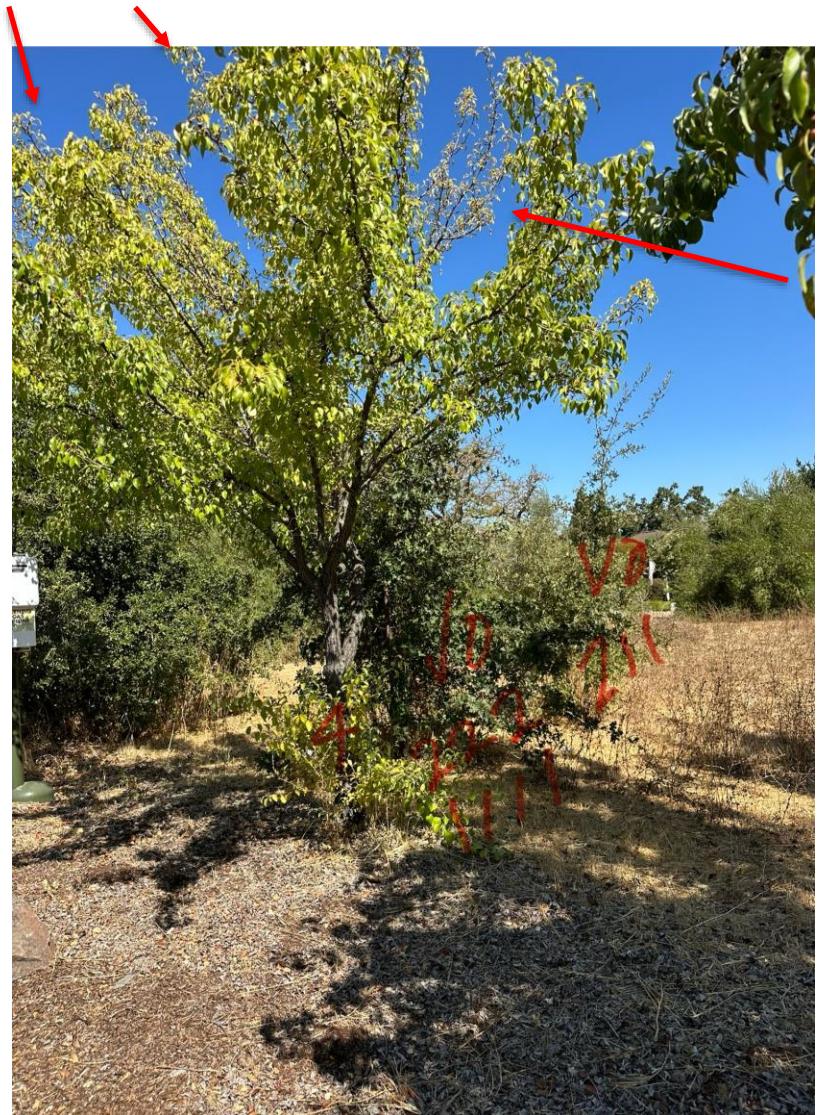
Photo #2. Trees along Jefferson Street. Note branches dying (red arrows)

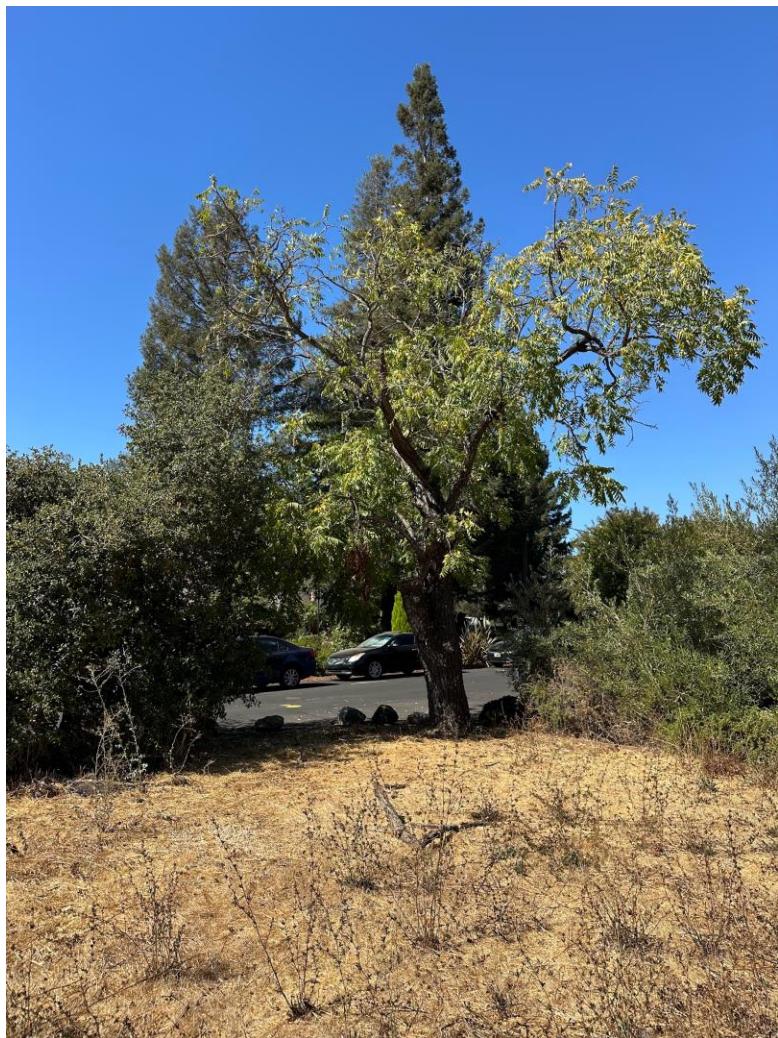
There is a California Black Walnut, *Juglans hindsii*, measuring 24" diameter at the northwest corner of the property. This tree has been in a decline cycle for many years. It has large dead branches and significant decay at the branch junctions. A risk assessment may indicate that an biennial severe pruning could keep the tree in the landscape for longer but it is likely to reduce the lifespan further and result in a tree with a poor aesthetic value. Accordingly, it is also my professional opinion that this tree be removed.

Photo #3. Tree #1, Walnut. Not much canopy looking west.

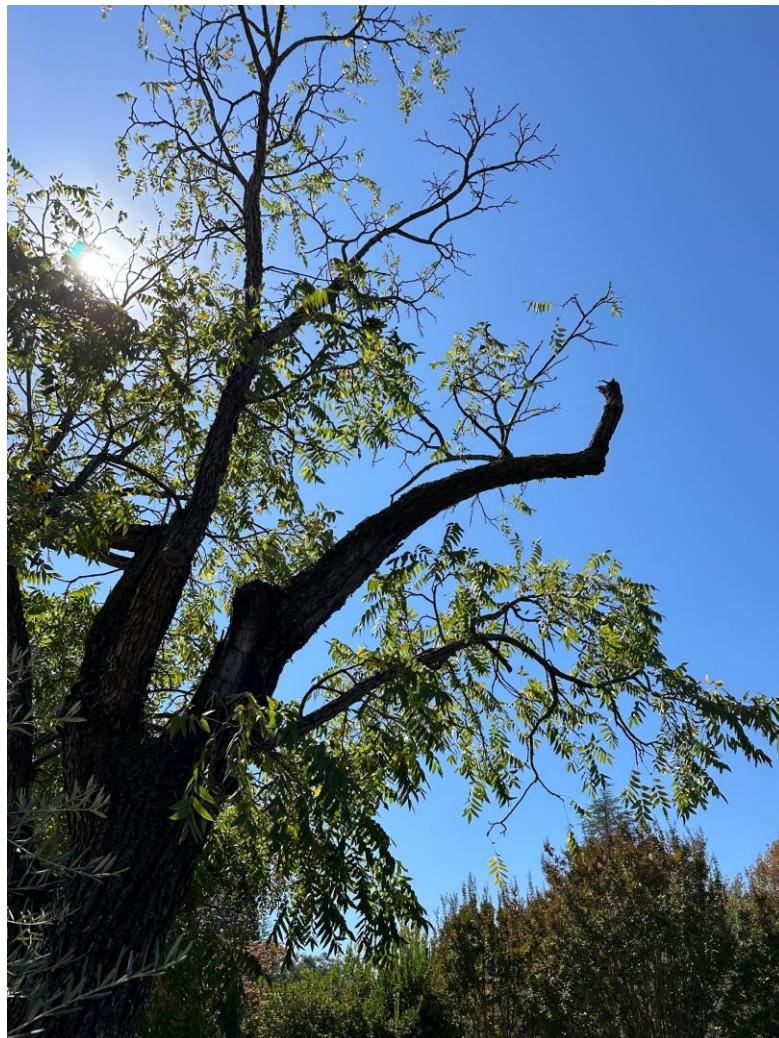
Photo #4. Tree #1, Walnut. Dead branches looking east.

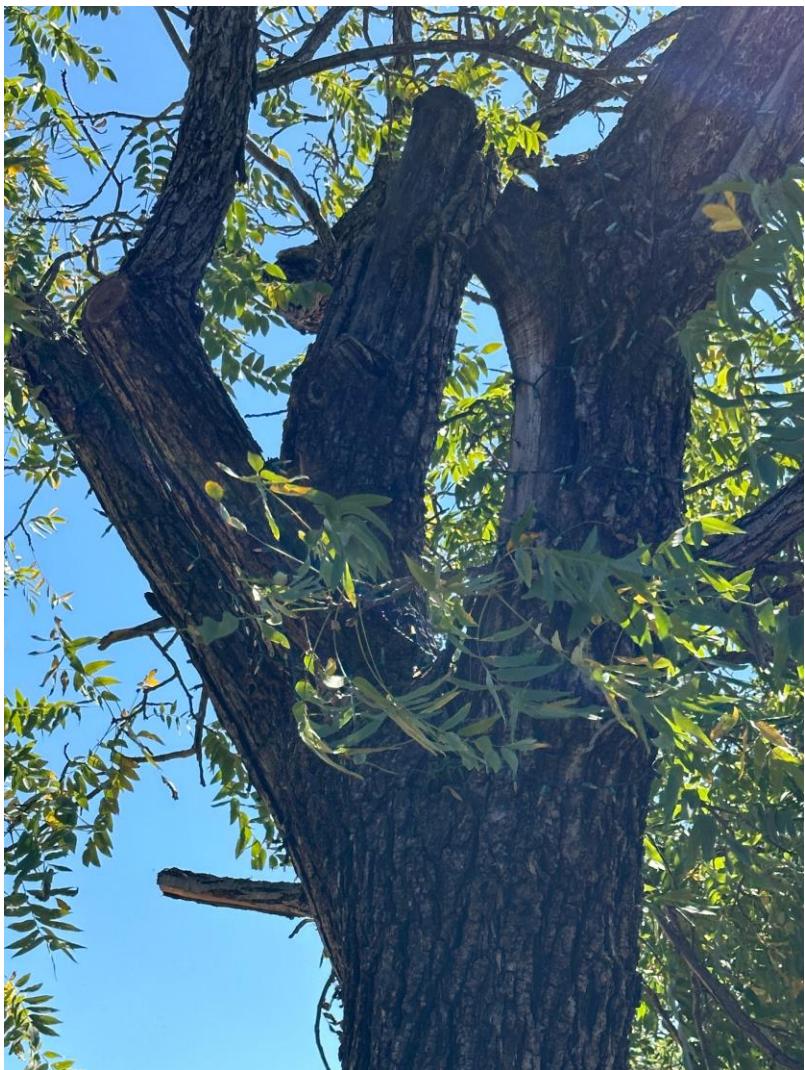
Photo #5. Tree #1, Walnut. Decay at main structural junction.

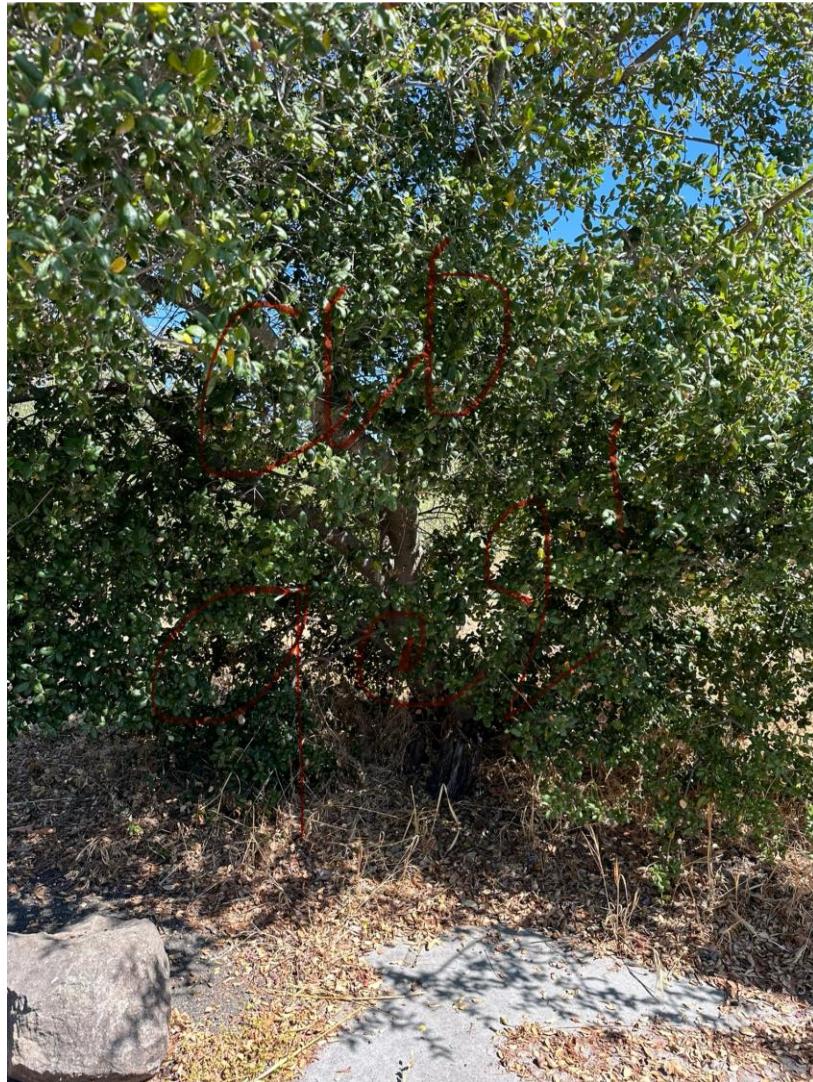
Photo #6. Tree #2, Coast Live Oak. Shrub form with multi-stem structure from 1'.
