Subject: Review of Health Condition of Heritage Oak along Hopper Creek Pathway

Arborist Report

Re: Oak tree exam

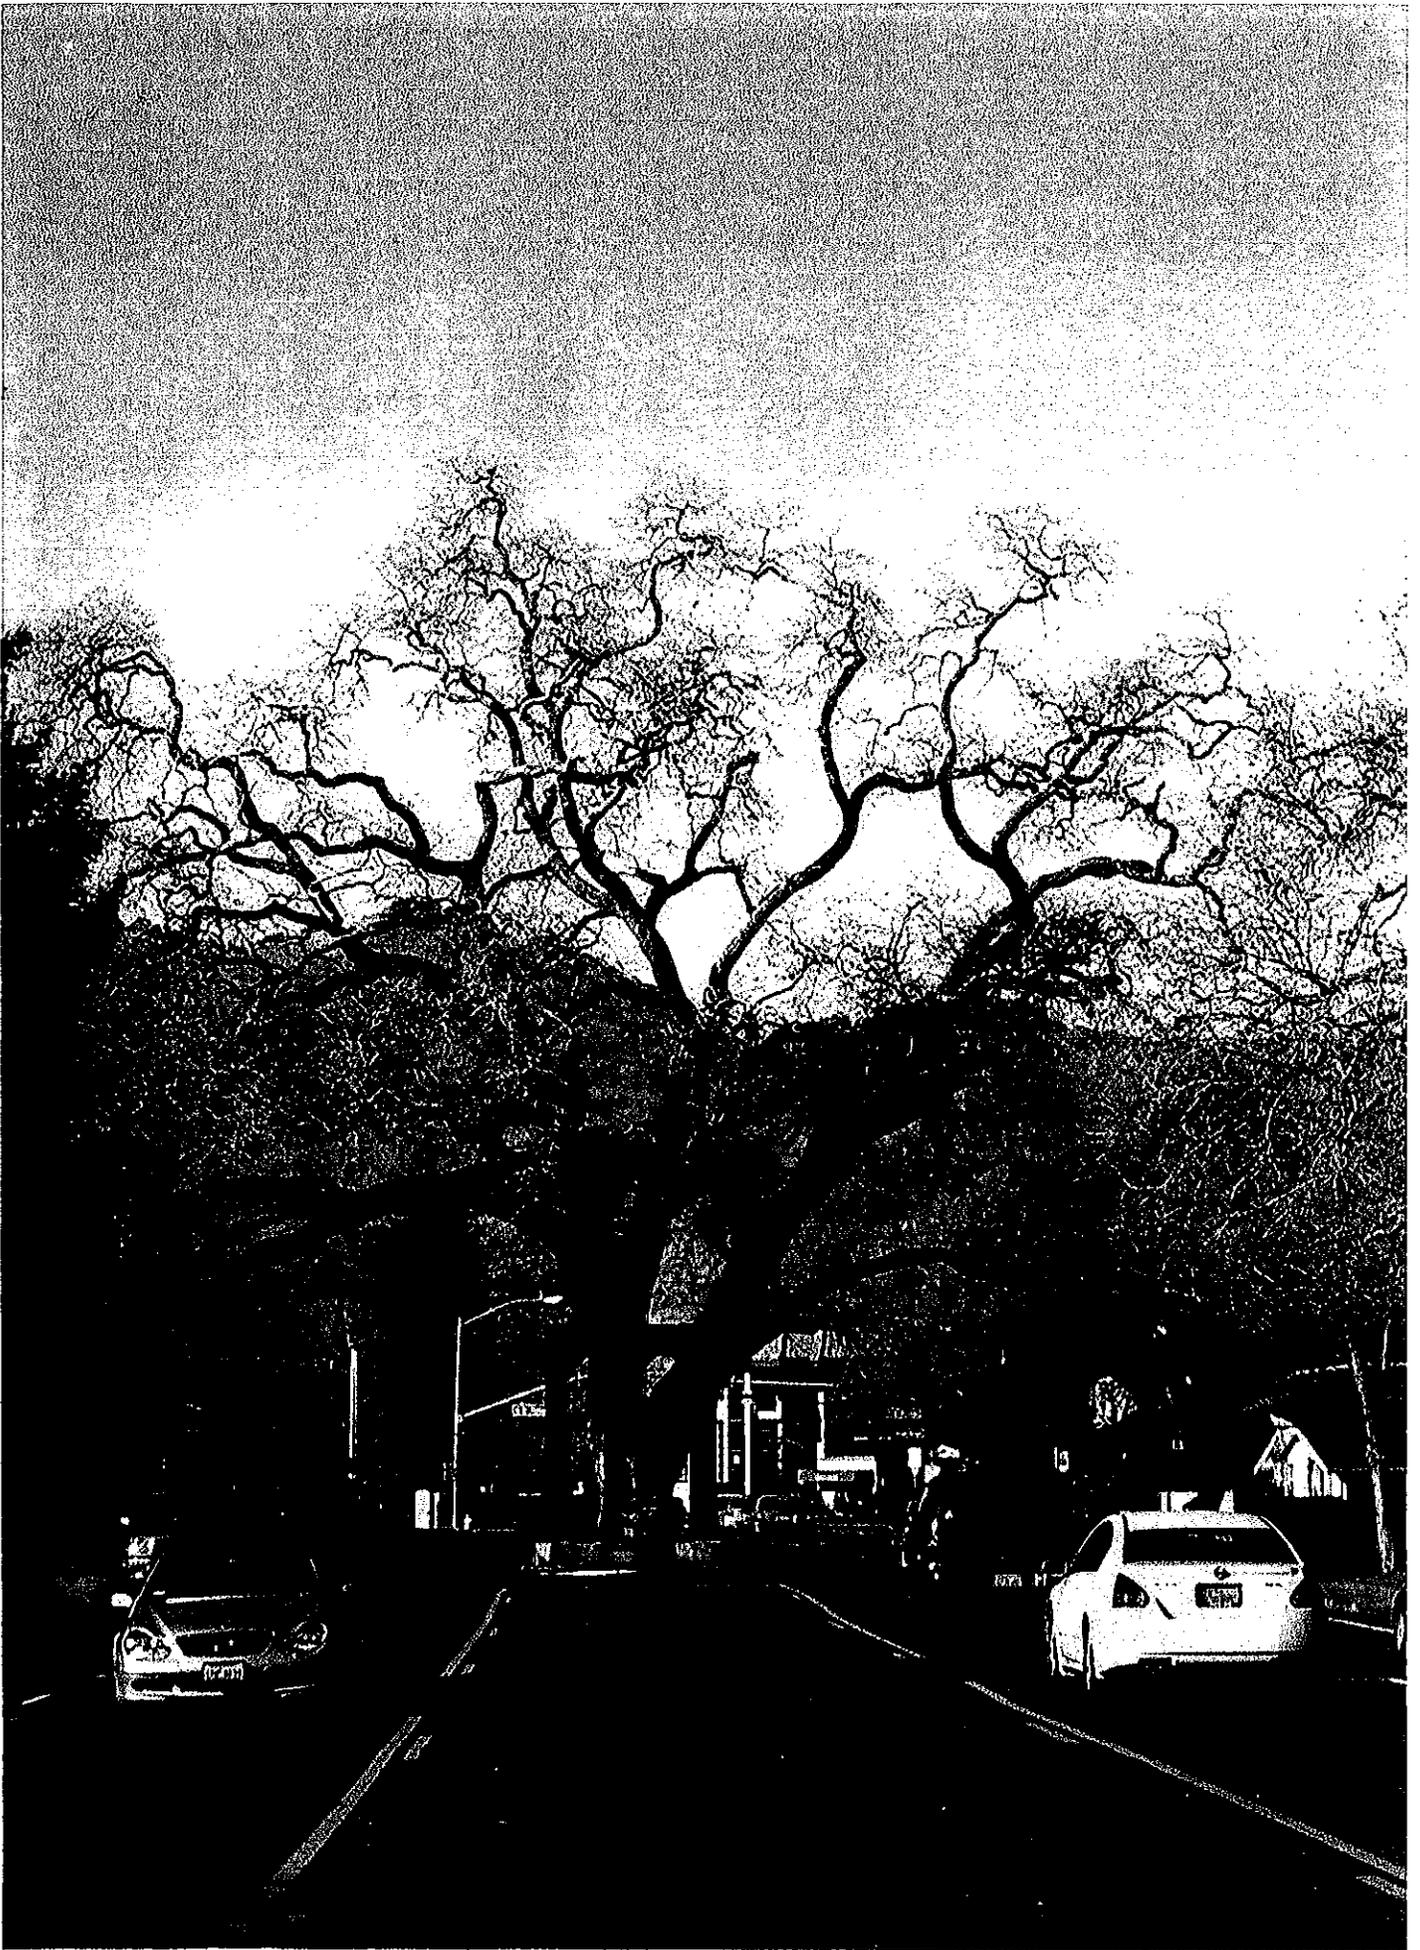
He explained that their signature (town logo) tree was preserved, using a heavy steel frame around but not touching the trunk. The frame was installed to protect the main thoroughfare, with the understanding that if the tree ever began to lean enough to touch the frame, the tree should be removed. (Coincidentally, he told me that the tree has just recently begun to lean enough to touch the frame.)
